CITY OF BANGOR

# HISTORIC PRESERVATION COMMISSION

HISTORIC PRESERVATION COMMISSION  
MEETING OF OCTOBER 8, 2026, 7:00 P.M.  
COUNCIL CHAMBERS, CITY HALL  
73 HARLOW STREET

The Project proposes the replacement of gutter lines, valleys, and downspouts. Additionally, the Project proposes the replacement of the upper roof and bay window roof, as well as the installation of five snow guards. The Project is located at 28 West Broadway, Map-Lot 022-065, in the Whitney Park Historic District.

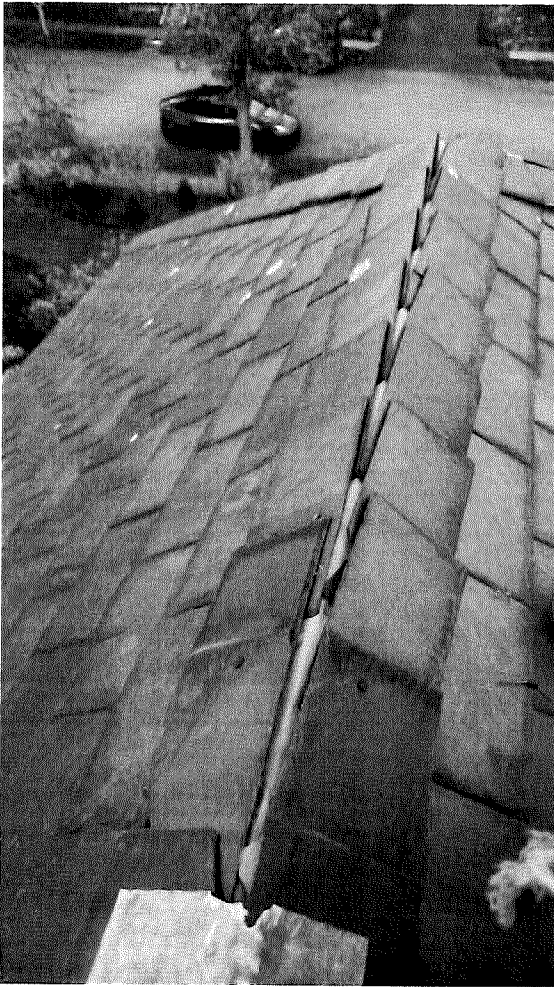
## Hips & Ridge

- Remove Slate Hips & Metal Flashing
- Replace with Slate Hips
- Previously approved by HPC
